Manhole Inspection Summary

Manhole # S35MM1008MH

Insp Date: **3/13/07 3:01 PM**

Location Address: **4504 EASTWAY**

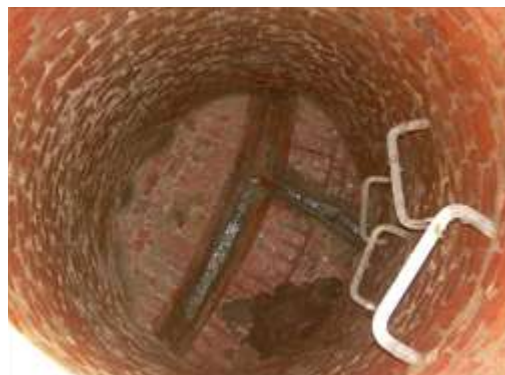
Top View

Adjustment and Barrel infiltration. Bench debris.

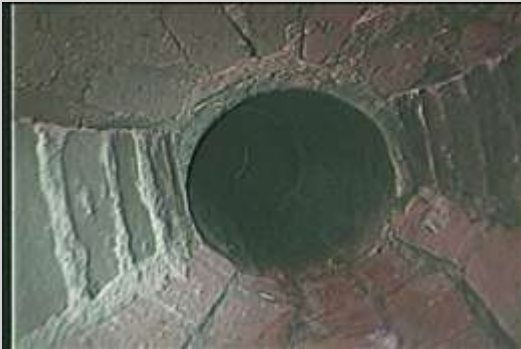
8 in. Circular Gravity Sewer Pipe Out @ 12 O'Clock

Infiltration: **Evidence** Pipe Seal Cond: **Unknown**

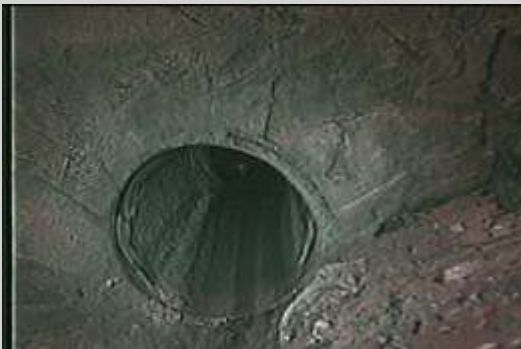
6 in. Circular Gravity Sewer Pipe In @ 3 O'Clock

Infiltration: **None** Pipe Seal Cond: **Unknown**

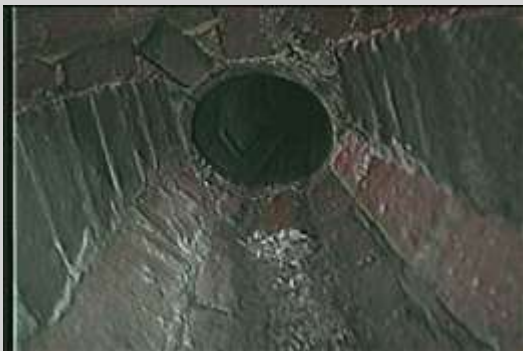
6 in. Circular Gravity Sewer
Pipe In @ 7 O'Clock

Infiltration: **Evidence** Pipe Seal Cond: **Unknown**
